**July 2005**

## **Flooding ravages Catchpool and Orongorongo valleys**

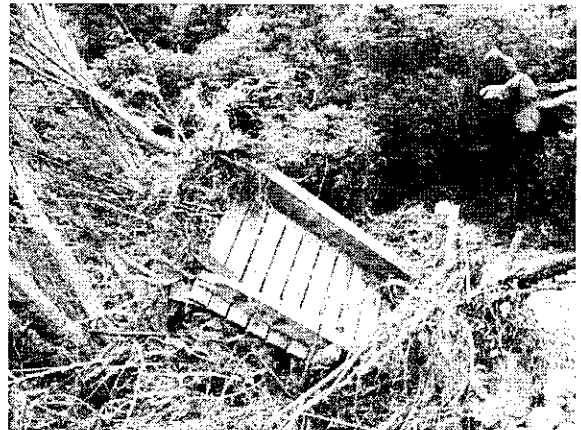
Both bridges on the Five Mile track washed away and the Orongorongo track was blocked in many places by fallen trees and slips. 8 bridges were either washed away buried or so badly damaged that they had to be removed. All bridges on the Big Bend track were washed away and a huge slip completely destroyed the northern end of the track

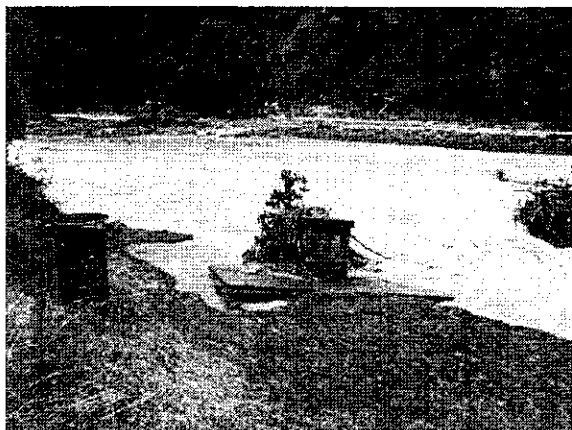
Facilities in the Catchpool Valley were damaged. Parts of the water supply pipeline washed away in several places, the ablution block and barbeque shelter in the camp ground were flooded, and the camp ground was closed for about a month. It has now re-opened minus half the camping area. Much of it was washed away, and access to the remaining area was destroyed.
